ROAD SAFETY AUDIT

HIGH STREET FROM MAIN STREET (ROUTE 27) TO
POWDER MILL ROAD (ROUTE 62)

ACTON, MA

MAY 18, 2021

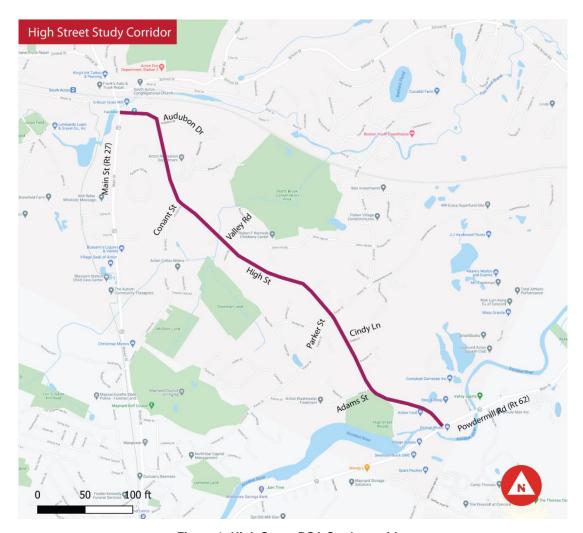
Figure 1: High Street RSA Study corridor

The project location is a 2-mile segment of High Street between Main Street and Powder Mill Road (**Figure 1**). High Street is primarily residential between Main Street and Old High Street and becomes commercial on approach to Powder Mill Road with businesses on both sides of the street. High Street is classified as an urban collector street and provides access between Downtown Acton near Main Street and Concord at the terminus of the corridor on Powder Mill Road. The South Acton commuter rail station (travelling on the Fitchburg Line to Boston) is across the High Street and Main Street intersection. The street functions as one lane in each direction with a centerline provided throughout the segment. The roadway width ranges from 25 to 30 feet. The posted speed limit of the corridor is 25 mph from Main Street (Route 27) to Conant Street, and 30 mph south of Conant Street. A speed study completed by the Town in 2018 shows an 85th percentile speed of up to 48 mph in some locations such as the Parker Street intersection¹.

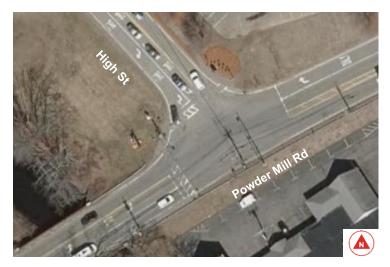
Figure 9: High Street at Powder Mill Road

High Street at Powder Mill Road (Route 62): The intersection of High Street and Powder Mill Road (see Figure 9) is a three-legged signalized intersection, with Powder Mill Road meeting High Street at the end of the RSA study area. Powder Mill Road is classified as an Urban Arterial roadway. The intersection is signalized for all approaches. The Powder Mill Road eastbound and westbound approaches both have one through lane and one left-turn lane to enter High Street. High Street approach to Powder Mill Road has one right-turn and one left-turn lane. Both streets have just one receiving lane. There are sidewalks on south side of

Powder Mill Road which terminate at the crosswalk on Powder Mill Road located on the west leg of the intersection. There are sidewalks on the east side of High Street as well as a crosswalk on the northern leg of the intersection.

Audit members noted that people driving may not see the traffic lights at this intersection which may have been the cause for a pattern of angle crashes at this intersection.

Audit members observed that there is a sidewalk only on the east side of the intersection without access for people going to the car dealership on the west side.

Consider adding reflective back plates to the signals for improved visibility. It should be noted that a structural analysis may be necessary to check for any impacts to wind loading requirements.

Explore the feasibility of providing sidewalks on both sides

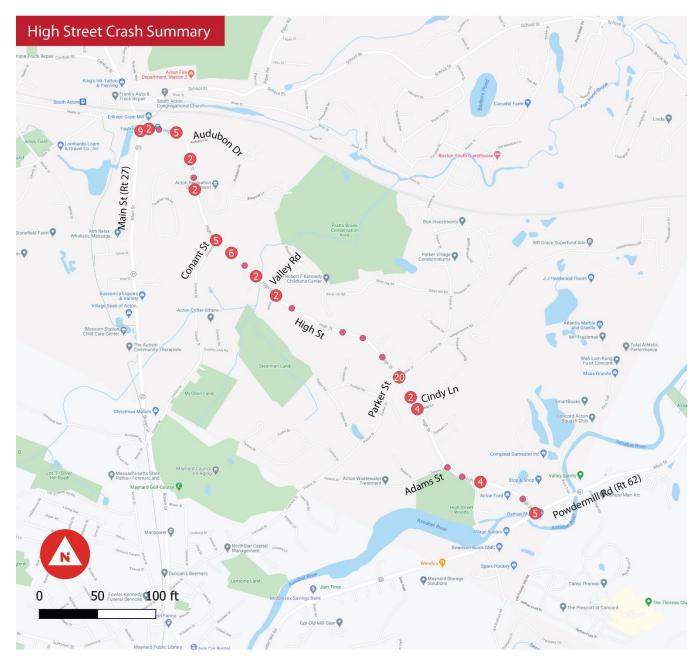
Figure 10: High Street crash locations

Figure 10 shows where the crash clusters are located within the corridor. Most of the collisions happened near Parker Street and Main Street intersections, representing 25% and 14%, respectively.
